TROUBLESHOOTING DIGITAL MODES

IS THERE A WAY TO TAKE THE AGITA OUT OF TROUBLESHOOTING?

Hoop K9QJS, with thanks to AD4CJ, W4DML, N4CCB

17 June 2023

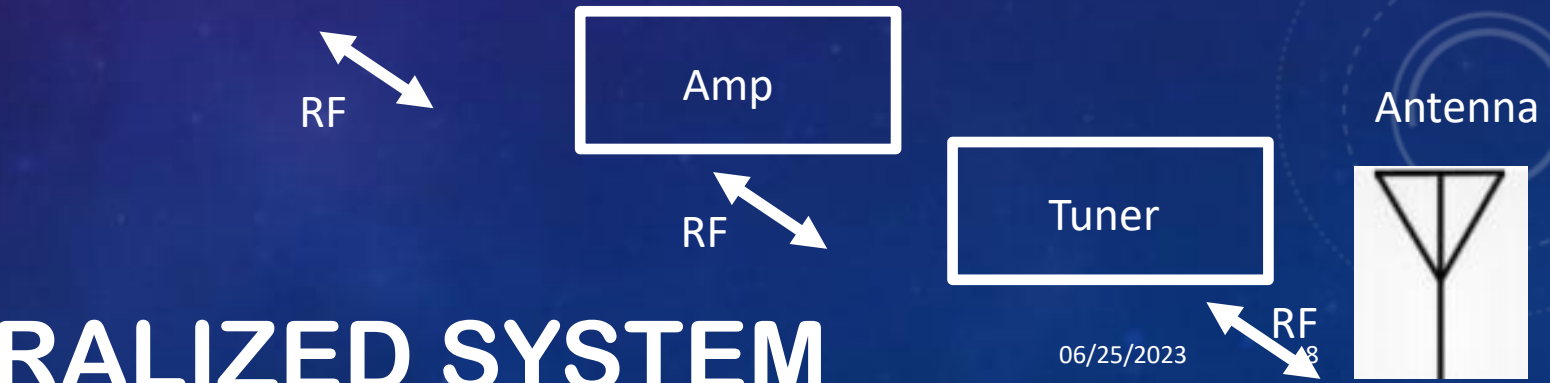
1. GENERALIZED SYSTEM

HF radios without USB interface, and most VHF/UHF radios, need a digital-mode interface such as Signalink, Digirig, et al.

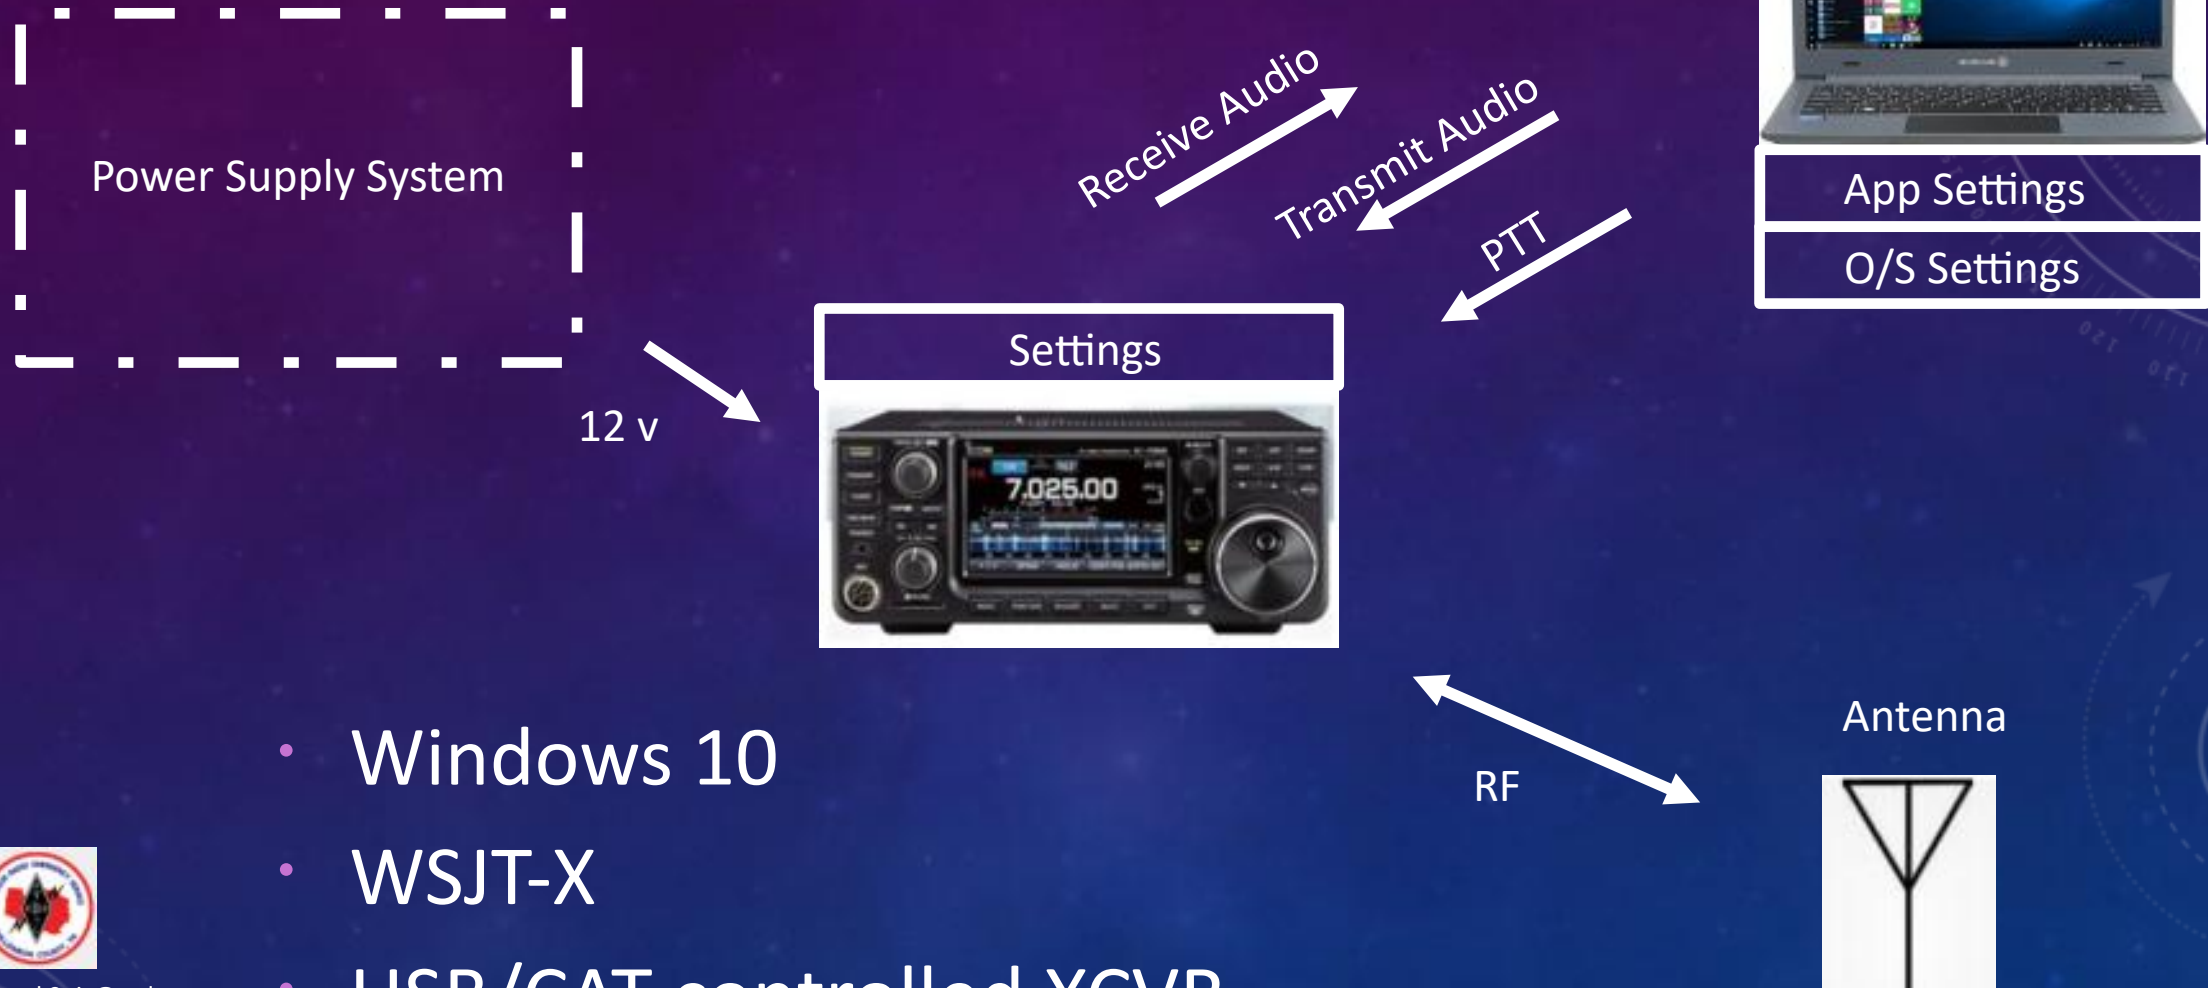
MY SYSTEM

- Windows 10
- WSJT-X
- USB/CAT controlled XCVR

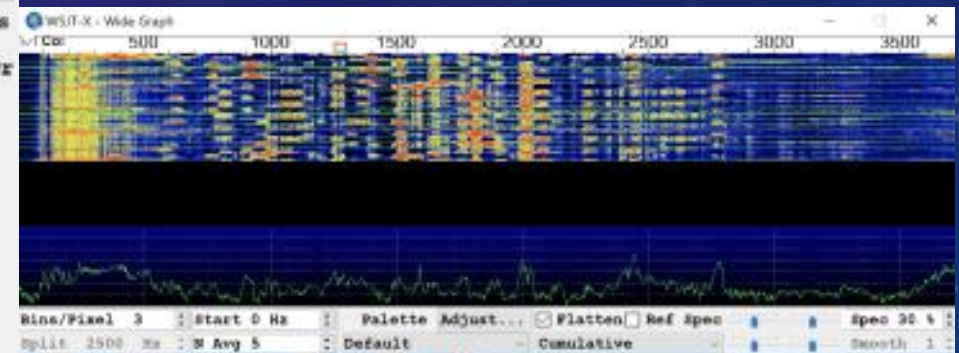
- Decoding is happening (but not strong decodes)
- App is “transmitting”

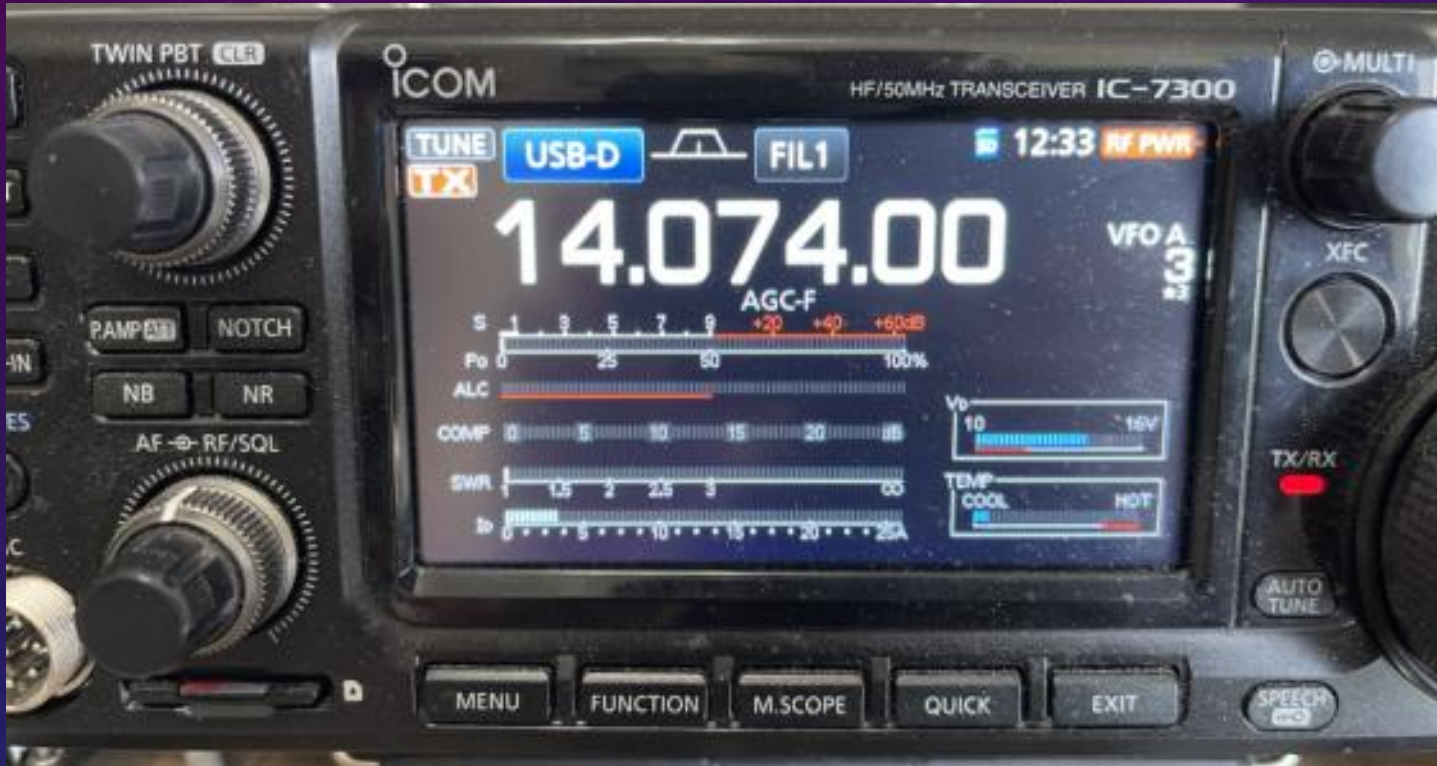
3. COLLECT DATA (DURING TRANSMIT)

- TX LED is on.
- Po (power out) - ZERO!

- Conclusion:
PTT activated, but no RF power output

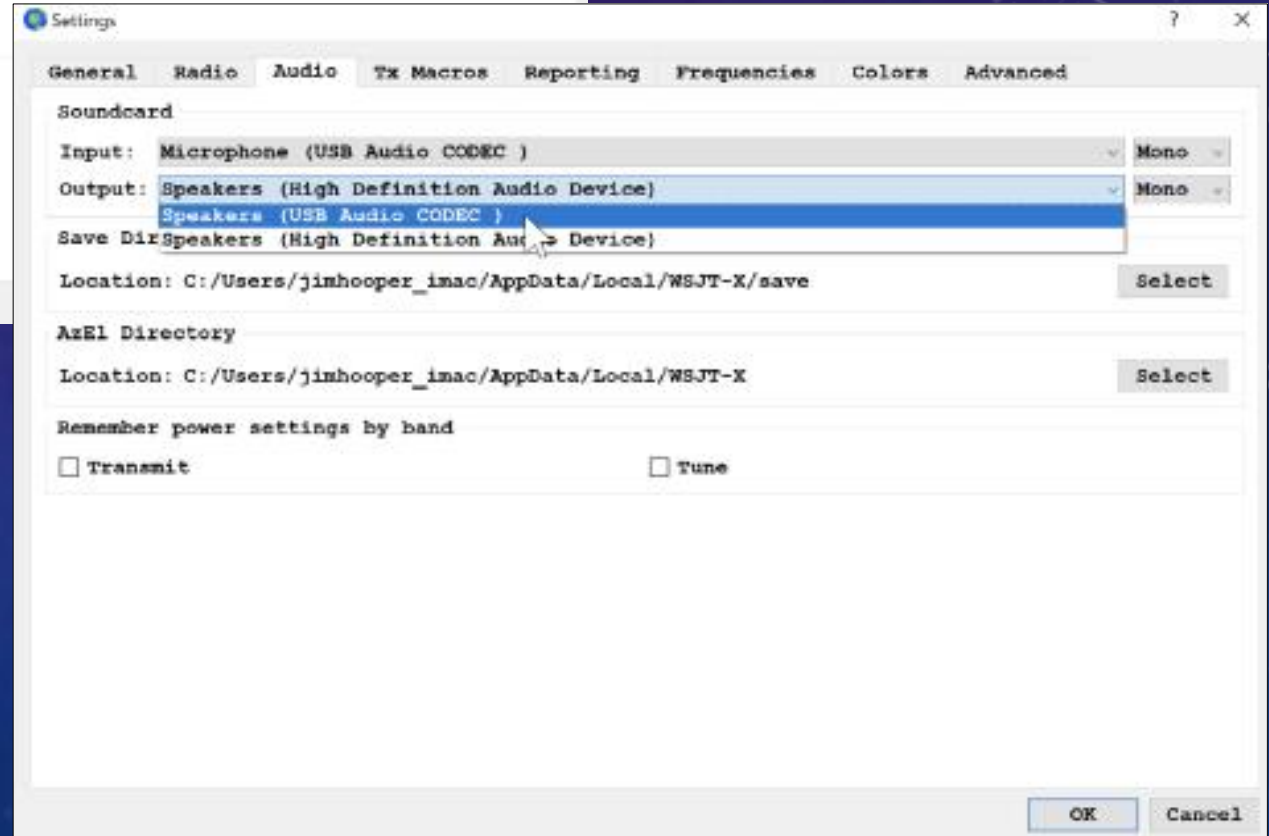
4.1.1. WSJT-X SETTINGS

Input: INTERNAL MIC
Output: INTERNAL SPEAKER

CHANGE TO "USB AUDIO CODEC"

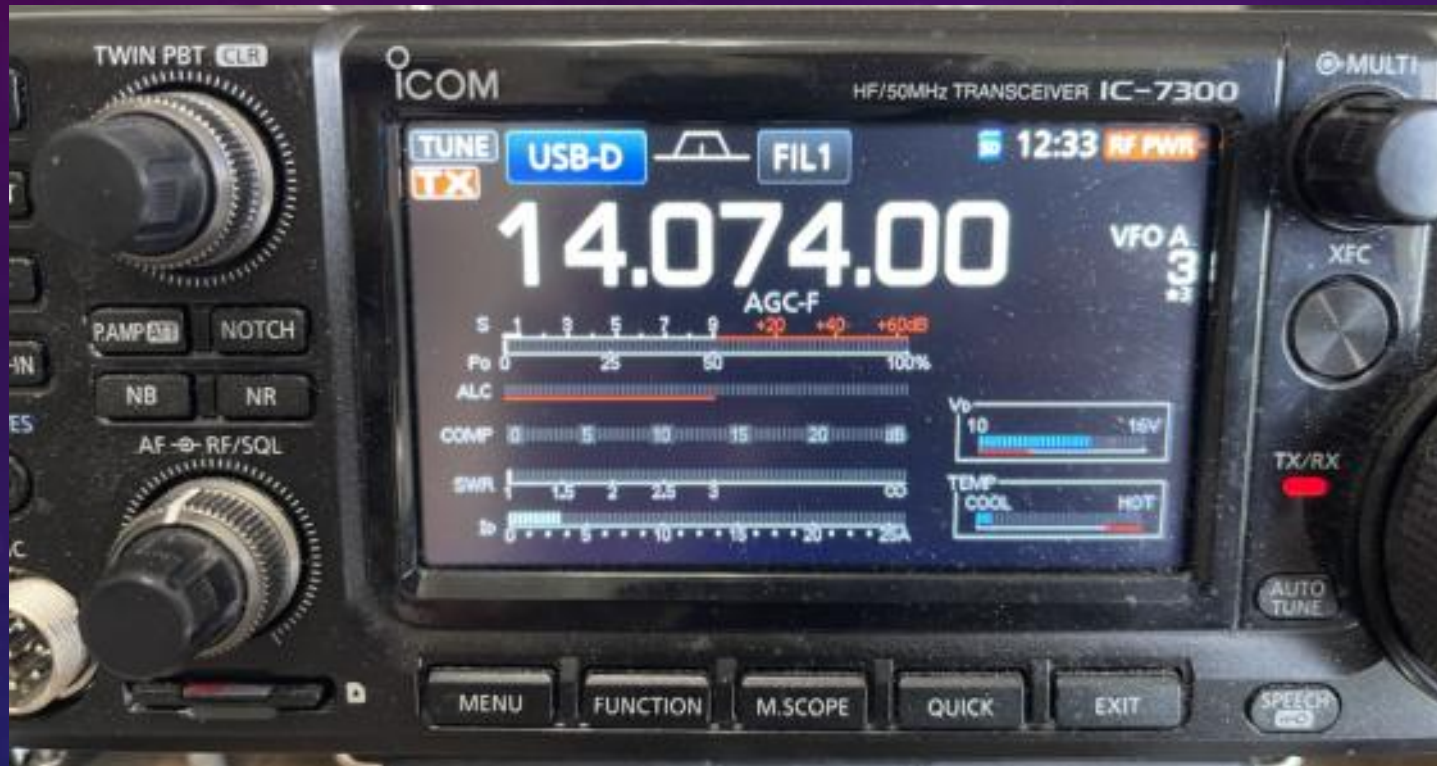
4.1.2. MORE DATA (DURING TRANSMIT)

- TX LED is on.
- Po (power out) – still ZERO!

- Conclusion:
PTT activated, still no power output

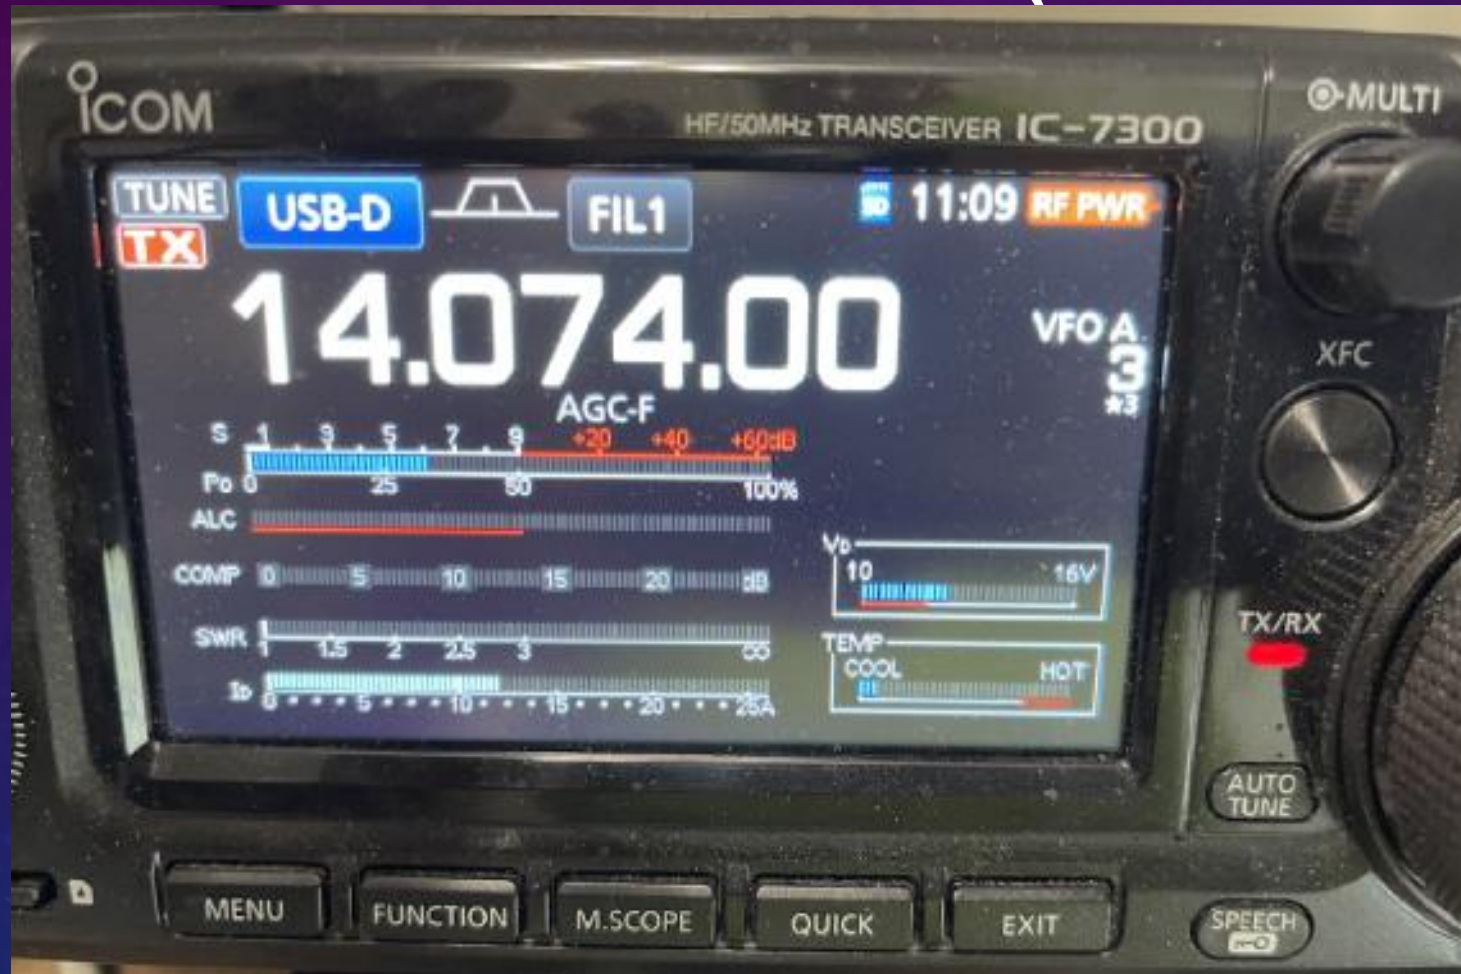
4.2.2 - COLLECT DATA (DURING TRANSMIT)

- TX LED on.
- $P_o = 30$ watts! ????

But XCVR setting is for 50 watts.

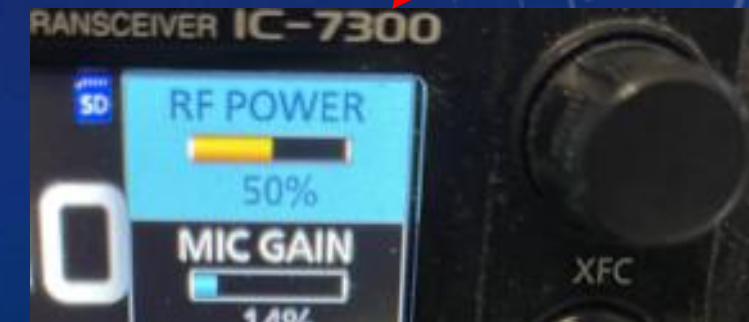
- Note: No ALC showing, good for 7300

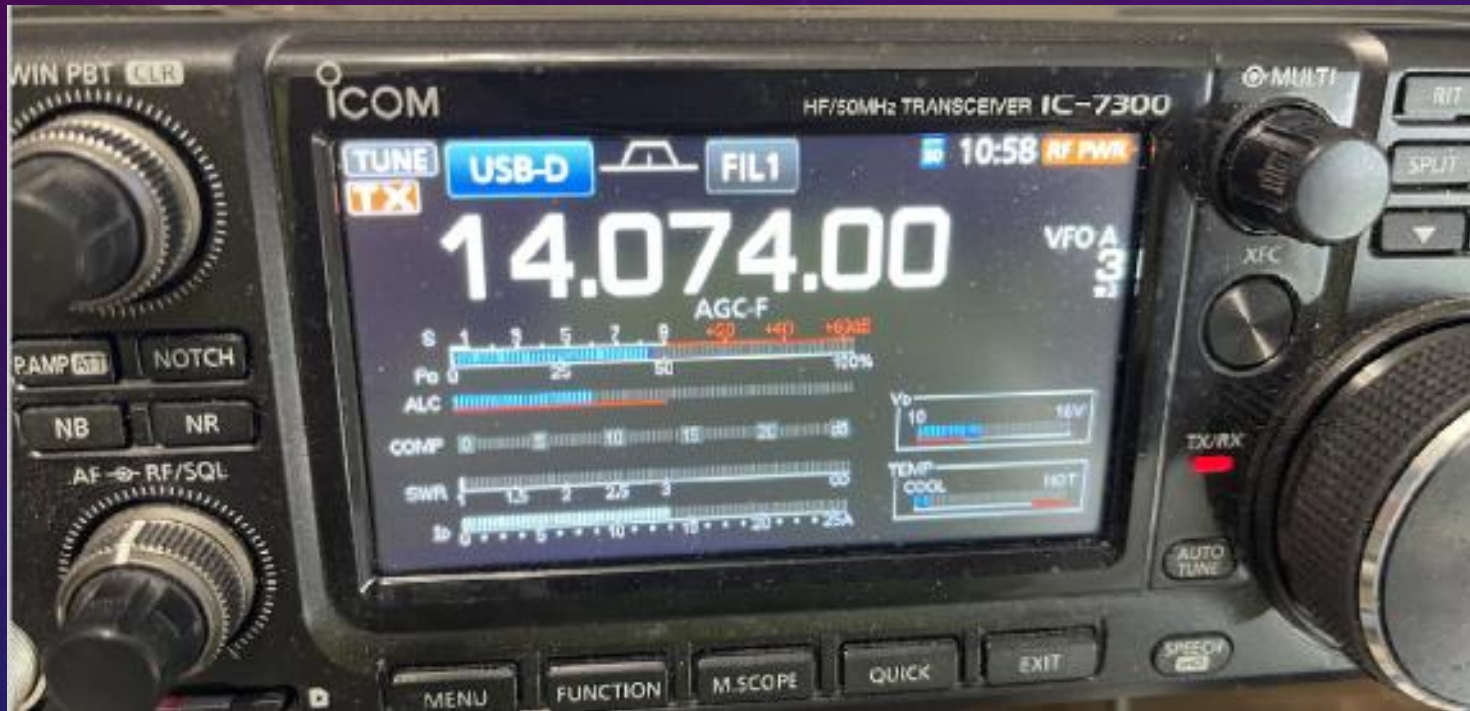
4.3.2 - COLLECT DATA (DURING TRANSMIT)

- TX LED on.
- $P_o = 50$ watts!
HOORAH!
- Complete success?
-> Let's try!

CAUTION: Too much ALC for 7300; need to dial back on PWR Slider. (Or O/S setting for loudness on "Speaker – USB Audio CODEC")
